Importance of Monitoring Air Handler Performance

Srinivas Katipamula and David E. Claridge,
Texas A&M University

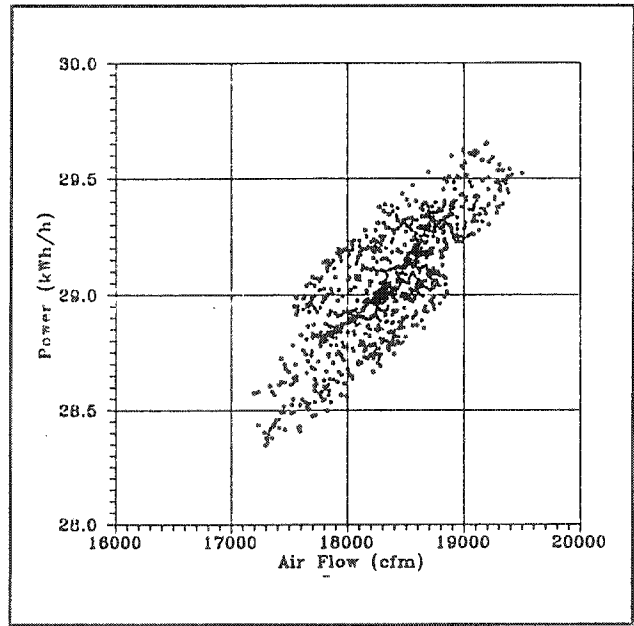
Figure 2. Fan Motor Power Consumption as a Function of Air Flow Rate

Fan power consumption as a function of air flow is shown in Figure 2. The power consumption of the constant volume fan motor over a period of seven months varied by only three percent while the flow rate varied by ten percent. The pressure drop across the fan remained constant at about 6.5 in. of water throughout this period.

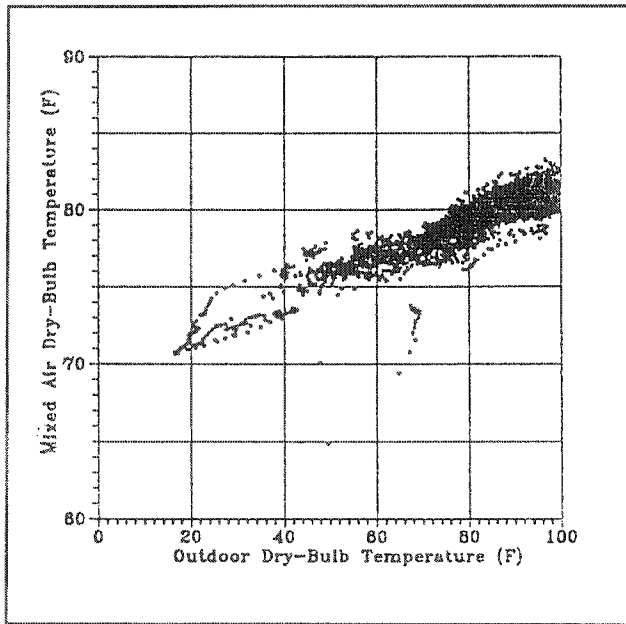
Figure 3. Mixed Air Dry-Bulb Temperature vs Outdoor Dry-Bulb Temperature

A cross plot of outdoor air temperature and mixed air temperature is shown in Figure 3. The mixed air temperature is strongly correlated with the outdoor air temperature, showing a slope of about 0.1°F per°F, consistent with 10% outdoor air. The scatter in mixed air temperature at fixed outdoor air temperature is probably due to changes in return air temperature or imperfect mixing. Time series graphs of outdoor air temperature and mixed air temperature for a two-week period in December 1990, are shown in Figure 4. On December 20, 1990, the outdoor temperature dropped from 75°F to 15°F, causing the mixed air temperature to drop from 75°F to 69°F, again consistent with 10% outside air. The operators normally close the outdoor air dampers when freezing weather is eminent and this would have reduced the heating load by approximately 2 MMBtu/h.

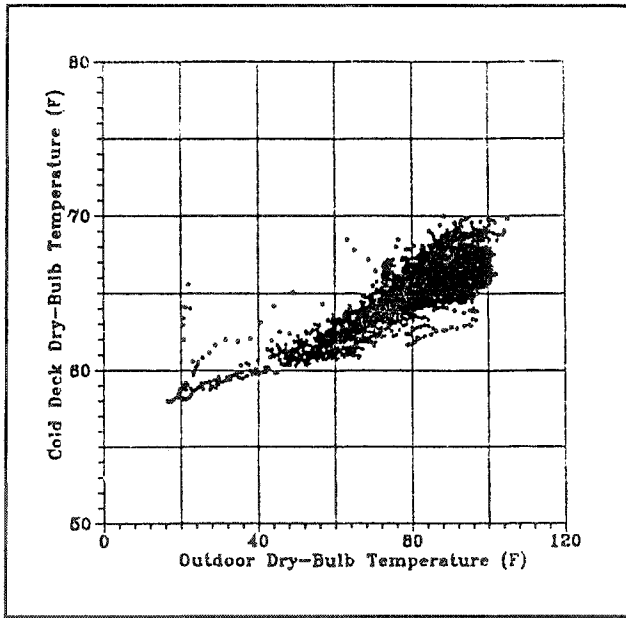
Figure 5. Cold Deck Supply Dry-Bulb Temperature vs Outdoor Dry-Bulb Temperature

The cold deck supply temperature also shows a strong correlation to the outdoor air temperature (Figure 5). The range in the cold deck temperature is the same as the mixed air range (14°F) and the scatter increases with outdoor temperature as well.

The design cold deck supply temperature was 53°F. However, the cold deck supply temperature never reached the design temperature during the monitoring period. Since the central plant did not have a strainer to filter dirt on its chilled water lines, the cooling coils were severely fouled, so parts of the cooling coil no longer cooled supply air. Therefore, they were effectively operating with a partial bypass. When the outdoor dry-bulb temperature was above 60°F, the variation in the cold deck temperature at a given outdoor temperature increased, probably due to changes in latent load and/or return air temperature.

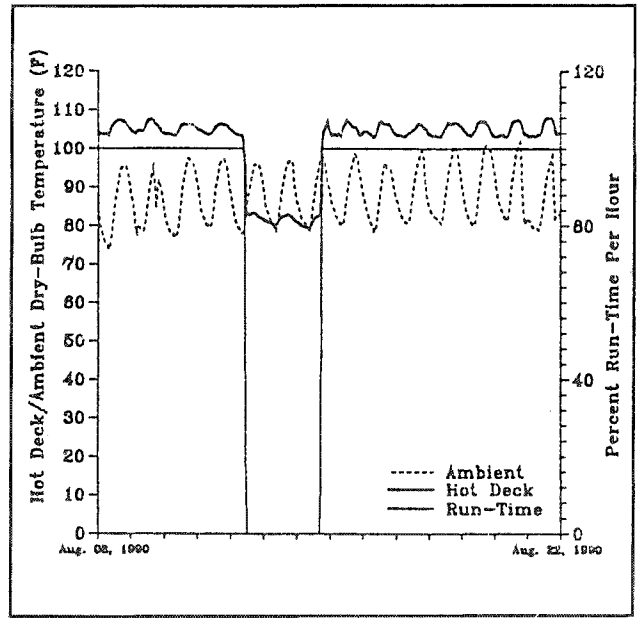
Figure 6. Hot Deck Supply Temperature vs Outdoor Temperature

The hot deck supply temperature was designed to be controlled by the outdoor air reset schedule shown as the solid line in Figure 6. The data points shown in the figure are the measured hot deck supply temperatures. The hot water pumps are supposed to be staged on when the pressure from the central plant is insufficient to meet the heating load. One of the two hot water pumps was on continuously, leading to hot deck supply temperatures above 100°F, except between August 12 and 14 when

both pumps were off (Figure 7) and the hot deck supply temperature dropped to 80°F. At low outdoor temperatures (below 40°F) the hot deck supply temperatures were lower than the schedule. If the second pump had been on during cold weather, the actual hot deck supply temperatures might have followed the schedule. However, the scatter in the hot deck supply temperature below 70°F is still large, indicating improper control.

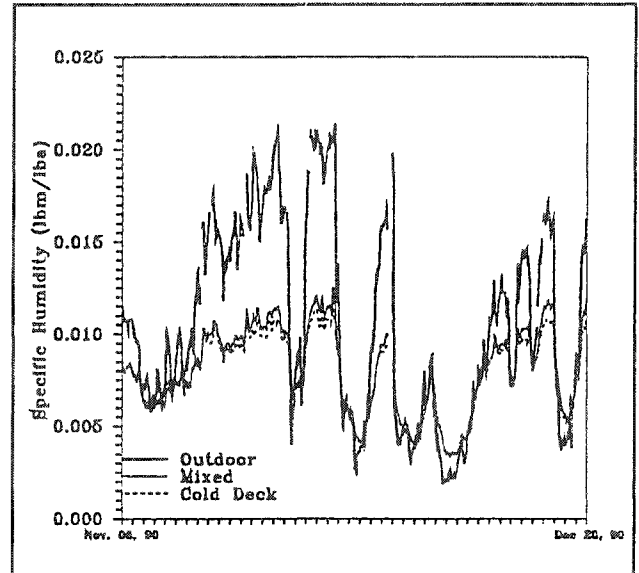
Figure 8. Mixed Air, Cold Deck and Outdoor Dry-Bulb Specific Humidities

Outdoor, mixed air, and cold deck specific humidities for November 8 to December 20, 1990 are shown in Figure 8. The mixed air and cold deck specific humidity profiles have the same trend. The average chilled water supply and return temperatures are 45°F and 55°F, respectively. The average coil surface temperature would be approximately 50°F. At 50°F dew point the specific humidity of the air is about 0.008 lbw/lba. Therefore, below a mixed air specific humidity of 0.008 lbw/lba, the specific humidity of the cold deck is approximately the same as that of the mixed air.
