# An Assessment of Compliance with Energy-Efficient Construction Program Requirements in the Southeastern U.S.

Cyrus K. Dastur, Advanced Energy

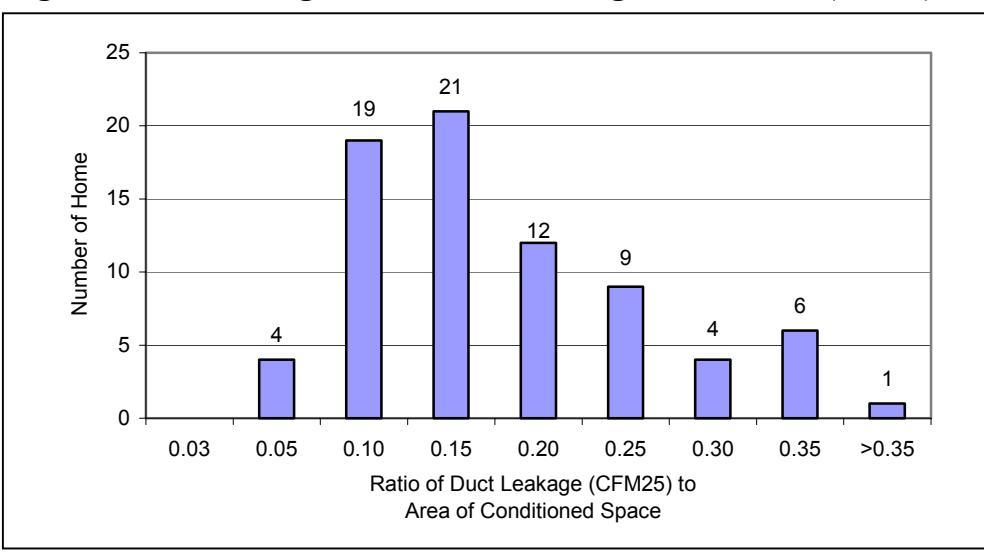
Figure 1. Duct Leakage Distribution for Program A Homes (N = 76)

The distributions of duct leakage ratios by program are illustrated in Figures 1 and 2. The number under each bar represents the upper limit of the ratio, e.g. the bar labeled "0.10" represents the number of homes that have a duct leakage ratio between 0.05 and 0.10. Notably, only one Program B home out of the twenty-two surveyed met the 5% duct leakage requirement.

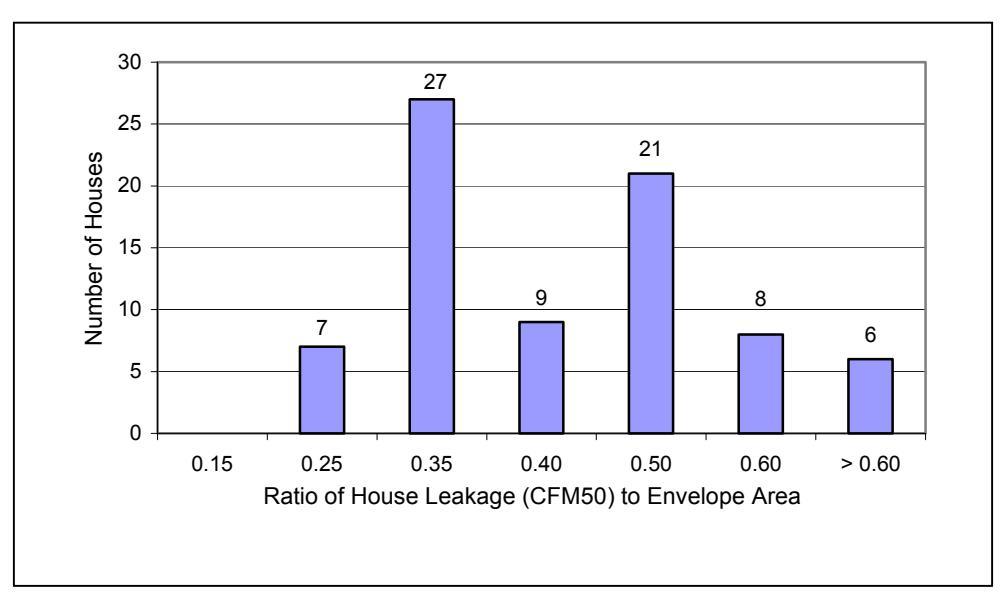
Figure 3. House Leakage Distribution for Program A Homes (N = 78)

The distributions of the house leakage ratios by construction program are illustrated in Figures 3 and 4. The number under each bar represents the upper limit of the ratio, e.g. the bar labeled "0.35" represents the number of homes that have a ratio between 0.25 and 0.35.
