# Field Monitoring of Wall Vapor Control Strategies in the Pacific Northwest

*Kohta Ueno, Building Science Corporation*  
*Aaron Townsend, Building Science Corporation*  
*Michael Lubliner, Washington State University*

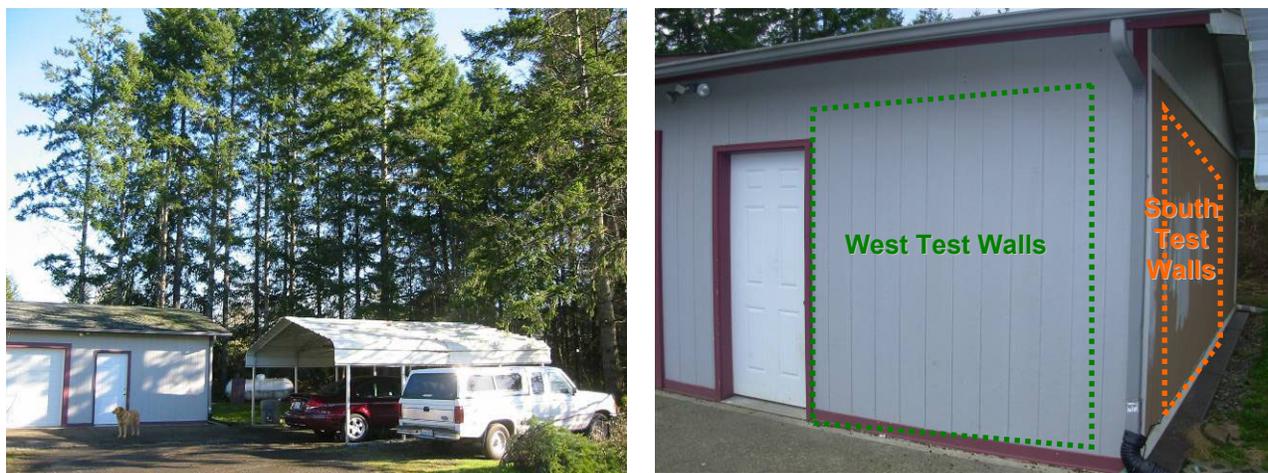
**Figure 2. Test Site, Showing Two Wall Orientations**

The full-scale test facility was an existing attached carport converted to an enclosed room by the installation of insulated infill walls, as shown in Figure 2.

The site was located in Olympia, WA, a DOE Zone 4C (Marine) climate, with 5531 HDD Base 65° F and 97 CDD Base 65° F. There were two sets of test walls: one (front) facing roughly west (260°), with no solar obstructions, and the other facing roughly south, shaded by tall trees. The space was used as a part time music studio during this research (i.e., intermittent occupancy). The door to the house was normally left open, and an exhaust fan in the test facility was run continuously. This would tend to result in similar dewpoint temperatures in the two spaces. Space heating was provided by a direct-vent propane stove, controlled by a thermostat. Since air conditioning is a rarity in the Pacific Northwest, no cooling system was installed.

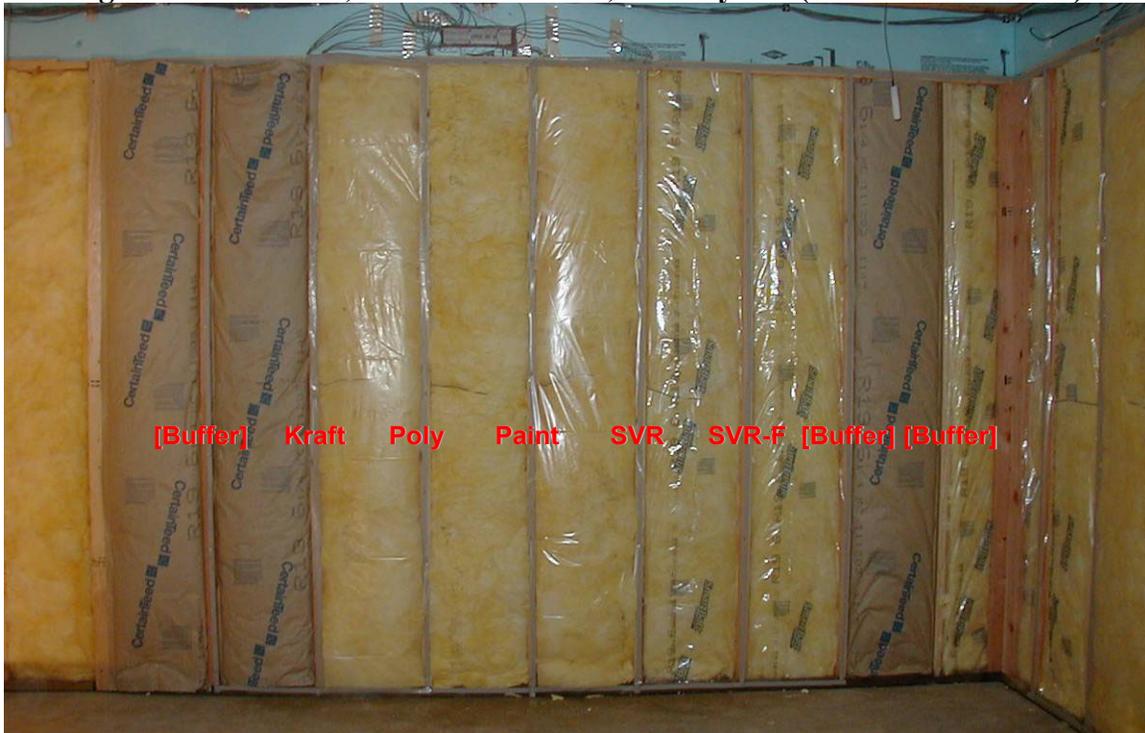
**Figure 3. Test Walls, South Orientation, Pre-Drywall (West Walls Similar)**

The south-facing test walls before the installation of drywall are shown in Figure 3 above; the west orientation has a similar setup.

Five identical (except for vapor retarder) test sections were built on each orientation, with one assembly per stud bay. The wall construction was (from exterior to interior; see Figure 4):

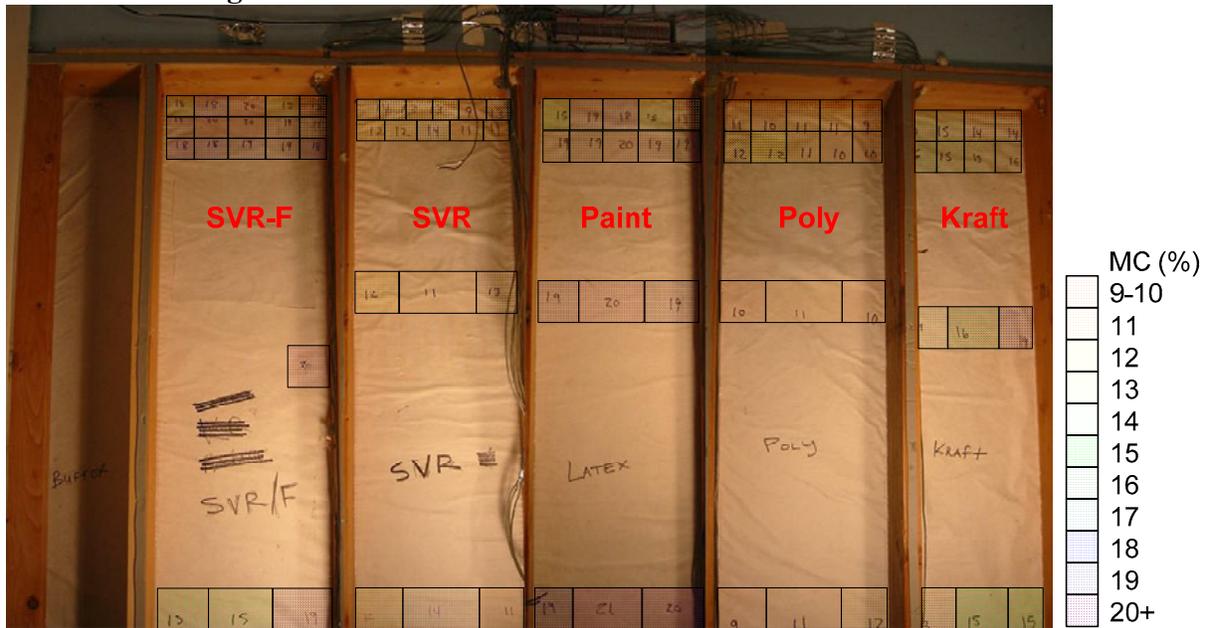
**Figure 8. Moisture Content Distribution in West Test Walls**

Additional moisture content measurements were taken to understand the spatial distribution of wall sheathing moisture contents; the results are shown for the west walls in Figure 8. The latex paint wall shows high (roughly 20%) MCs throughout: this is consistent with the measured data shown in Figure 6. The polyethylene and SVR (film layer) all have consistently low MCs, also matching collected data. However, the PA-6 wall with an inset-stapled facer (“SVR-F”) shows significant moisture accumulation at the top of the wall cavity (18-20% MC), relative to the mid-height measurements (~15%). The Kraft wall shows intermediate moisture contents (14-16% MC).

In the South walls, similar patterns were observed; the SVR-F and Kraft walls both show noticeable increases in moisture content at the top of the wall cavity.

The distribution of moisture content measurements in the stud bay revealed that inset stapled batt walls typically had elevated moisture contents at the top of the wall, relative to mid-height (the location of data logger sheathing measurements). This was evidenced in both test and non-test (buffer) bays. In two cases (West SVR-F and South SVR-F buffer), sheathing moisture content levels at the top of the stud bay were equal to those seen in the latex paint-only wall (18-20% MC).
