Importance of Monitoring Air Handler Performance

Srinivas Katipamula and David E. Claridge,
Texas A&M University

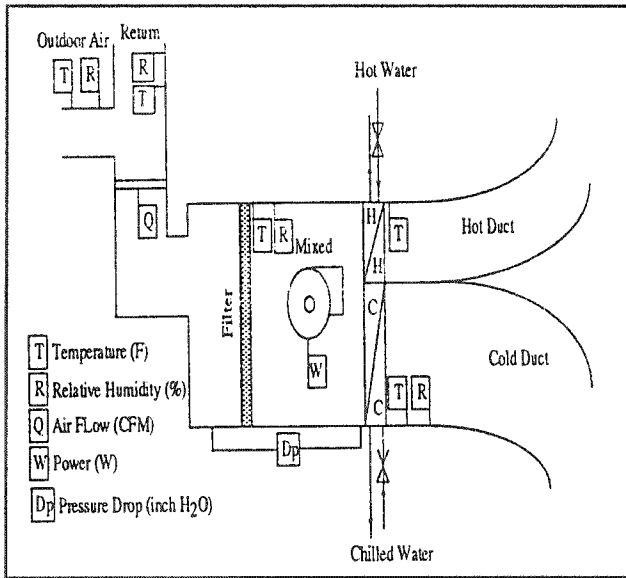
Figure 1. Air Handling Monitoring Schematic

The monitored air handler (AHU-10) is a dual-duct constant volume (DDCV) system with a flow rate of 20,000 cfm including 2,000 cfm of outside air when the outside air damper is fully open. It has a motor rated at 40 hp (29.8 kW). The heating coil is a two-row fin and tube heat exchanger with a surface area of 34.66 ft² while the cooling coil has eight fin and tube rows with a surface area of 62.16 ft².
