# RADON IN HOMES: THE ALASKAN EXPERIENCE

Richard D. Seifert, Energy and Building Specialist  
University of Alaska

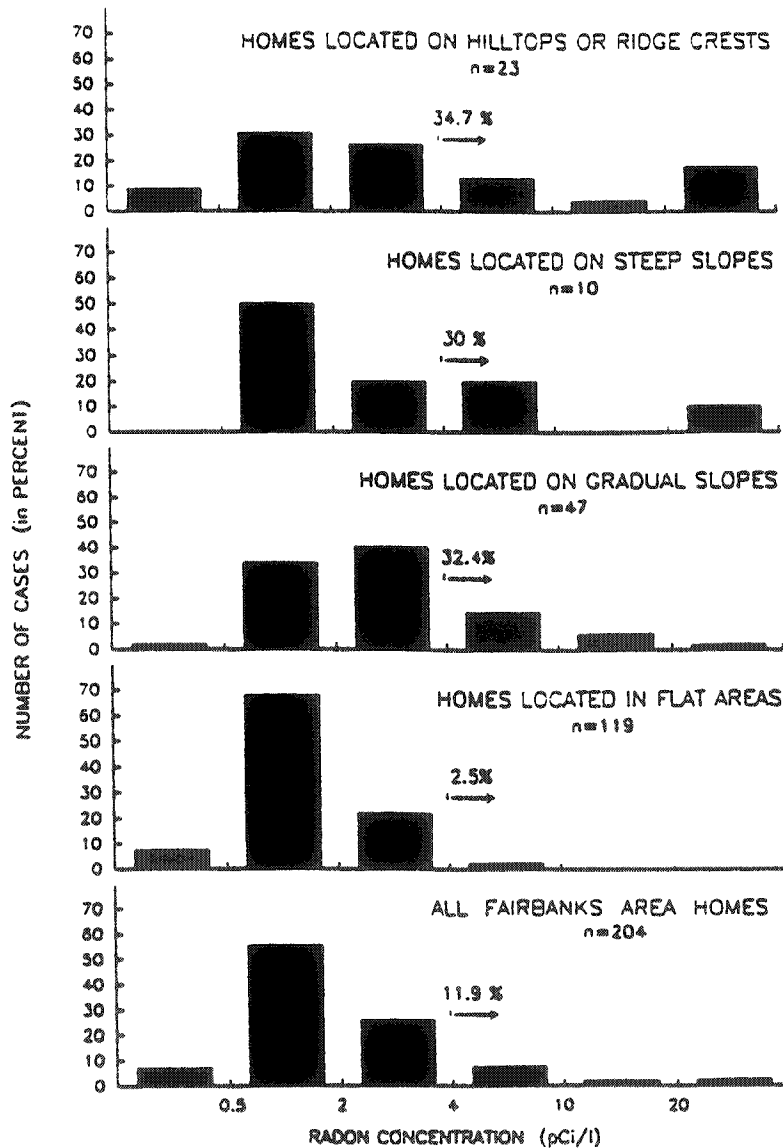
Figure 1. Histograms Summarizing Radon Screening Measurements and Local Geography of Fairbanks Area Homes (after Nye and Kline 1990)

Along with the confirmation of these radon risk characteristics, the Alaska/EPA survey found that, "Interior Alaska has the highest proportion of homes with elevated radon concentrations as well as the individual homes with highest concentrations. In the Interior, 3% of homes within the sample population had screening levels higher than 20 pCi/l and 17.6% of homes had radon screening levels that were higher than 4 pCi/l. Figure 1 summarizes the responses to a request for home site geographic information which was included with the report of test results that was sent to participants in the survey. This figure shows that 30 to 35% of homes built in the hills around Fairbanks have elevated radon concentrations.

"In the Fairbanks area, homes built in the hills surrounding town with concrete slabs or basements in contact with bedrock yielded the highest radon screening levels. These areas also had the highest proportion of homes with basements in contact the bedrock that did not have elevated radon concentrations. The data shown in Figure 1 for homes located on hillside sites, includes homes which are built on thick accumulations of windblown glacial
