Long-Term Interstitial Moisture Performance of a Tight Energy-Efficient Residence

Mike Nuess, Washington State Energy Office

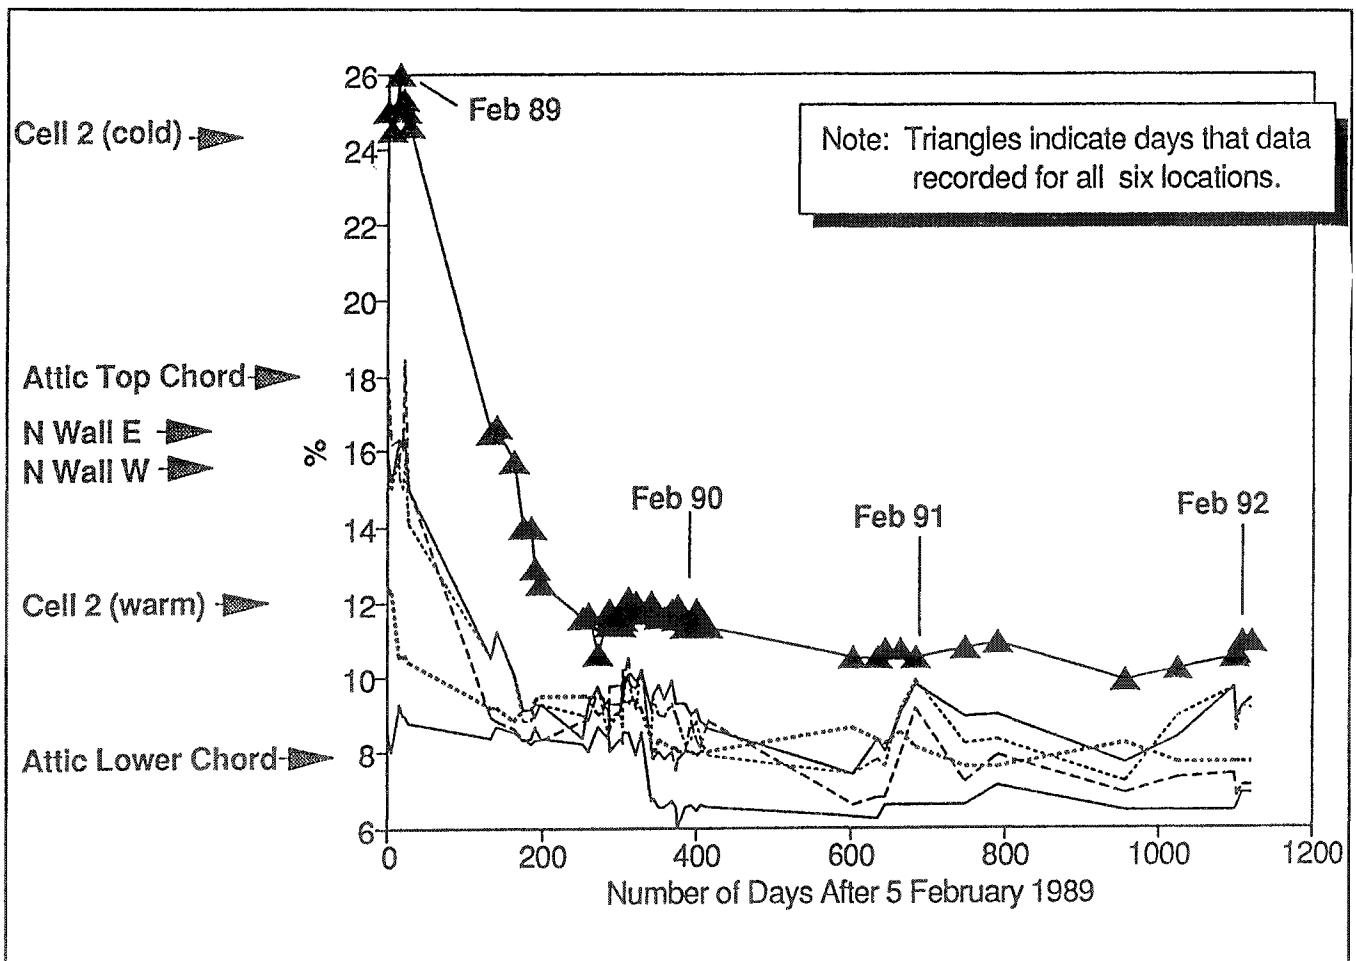
Figure 2. % Moisture Content in Structural Wood. Six critical building shell locations.

Complete sets of recorded data included moisture sensor readings at each of six locations, indoor temperature, and outdoor temperature. Fifty-three sets of complete readings were recorded. Forty-one sets were recorded in the first 13 months. Recordings occurred approximately weekly during the first heating season (Figure 2).

Construction of the building shell took place in the late fall of 1988. High moisture levels occurred during this period, particularly in the crawlspace zone. The building was commissioned and occupied in January of 1989. Interstitial moisture levels at the sensor locations remained at initial levels through March. By June, moisture levels in five of the six locations had dropped to what would remain baseline levels over the next three years. By the end of August, moisture levels in the sixth location had also dropped to what would remain a baseline level over the next few years. Moisture levels did not appear to increase above the baseline during the next three heating seasons.

The results indicate that a potential for moisture problems has not occurred, even in the pressurized area. Moisture levels in the sixth location (rim joist area) were consistently higher than in other areas due to the continuous pressurization of this zone, but remained well within acceptable limits. Extensive care was taken to insure installation of an effective and durable air/vapor barrier (Nuess 1991) in this zone, and this level of care was likely quite necessary. The effectiveness of this air/vapor barrier system could be better evaluated by creating deliberate openings near the sensor location and measuring the changes in wood moisture content.
