# **A Case Study of a Successful Innovative Multi-Unit Residential Building**

*Duncan Hill and David Carruth, Research Division, Canada Mortgage and Housing Corporation*

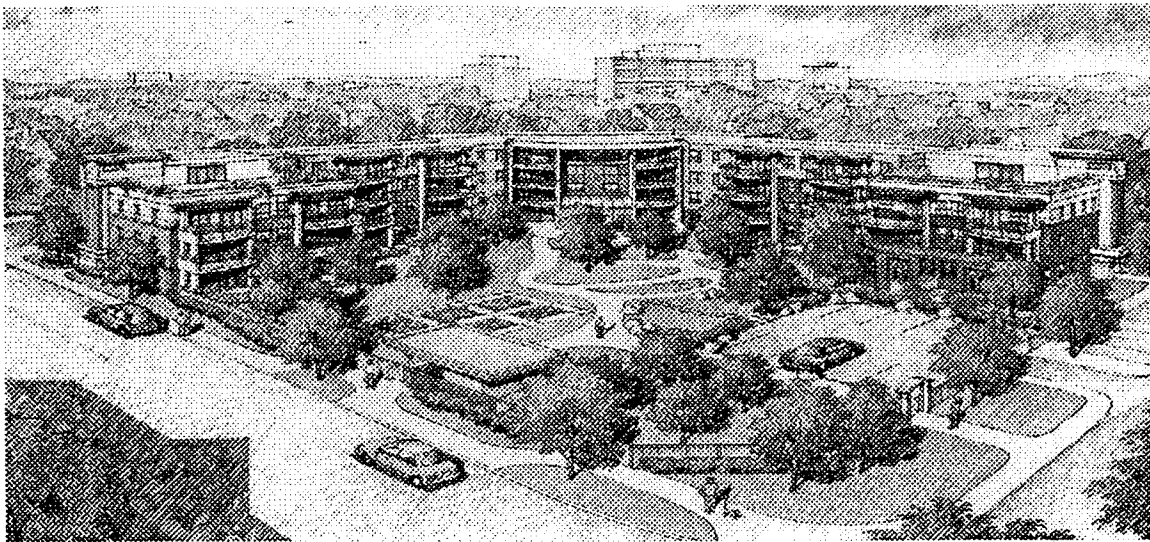
**Figure 1: Conservation Co-op Building and Site**

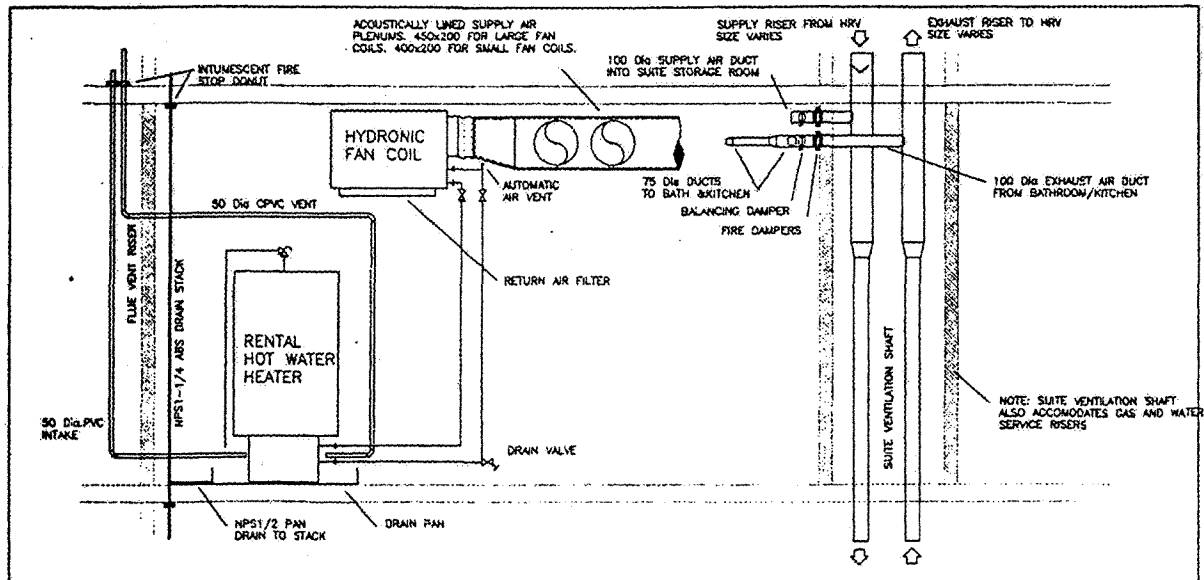
TYPICAL SUITE HEATING SYSTEM DETAIL

**Figure 2: Schematic of Apartment Space and Domestic Hot Water Heating System**

Each apartment contains a combination space and domestic hot water heating system (Figure 2). A high efficiency, condensing, natural gas domestic hot water heater provides hot water to a ducted fan-coil system for space heating. The heater also provides domestic hot water. Two 50 mm plastic pipes, side-wall vented or directed up through the roof, provide combustion air and vent the combustion products produced by the water heater. Within the apartments, each room receives warm air from the fan-coil through a short ductwork system. High wall, supply air grilles direct warm air into the rooms at ceiling level. Perimeter heating is not required due to the high thermal resistance of the walls and windows. Air is returned to

the fan-coil via door undercuts and a central return air grille. Programmable thermostats control the space heating system in each apartment, giving the residents a high degree of control over indoor conditions and reducing fuel bills via the setback feature. Natural gas use is metered for each apartment to encourage accountability and responsible usage.

A steel reinforced, poured concrete, structure, supports the building. Freestanding columns support the balconies eliminating a major source of thermal bridging, heat loss, comfort problems and condensation-mould growth on adjacent floor and ceiling areas. Construction is also simplified as the building structure could be cast with conventional concrete while the balcony structures are cast separately with more durable air-entrained concrete. The roof is a flat concrete deck with an inverted membrane system (membrane is below the insulation) insulated to RSI 7.04 ( $RSI = R\text{value} \times 0.1761$ ). The exterior walls are a combination of brick-veneer and stucco cladding systems insulated with 140 mm cellulose insulation and 38 mm of extruded polystyrene providing RSI 4.93. The below grade wall components are insulated using exterior grade, 50 mm, rigid insulation, RSI 1.76, to a depth of 610 mm below grade. Most of the windows in the building are double glazed, low-E, argon-filled, vinyl frame windows with insulated spacers. Well-developed air barrier details were integrated into the building envelope design and the air barrier system was well sealed. Solar gains are controlled by sunscreens incorporated into the balcony structures that provide shade in the summer but allow sunlight through during the winter (Figure 2).

**Apartment Space and Domestic Hot Water Heating Systems:** The use of rental hot water heating equipment allowed the reallocation of the construction budget to other “green” building features. It also placed water heater maintenance and replacement responsibilities with the local gas utility. However, the residents must pay rental fees that, in some cases, are more than the costs of the natural gas consumed each month. The relatively high rental charges (\$30CDN /month) has been an ongoing irritant to the building’s residents. The presence of the individual gas meters also incurs a monthly service charge for each apartment and limits the opportunity to capitalize on commercial gas rates and bulk gas purchases. The use of individual natural gas appliances within each apartment also limits the future fuel flexibility of the building. Conversion to alternative energy sources would be more easily accommodated at some point in the future had a central boiler been installed

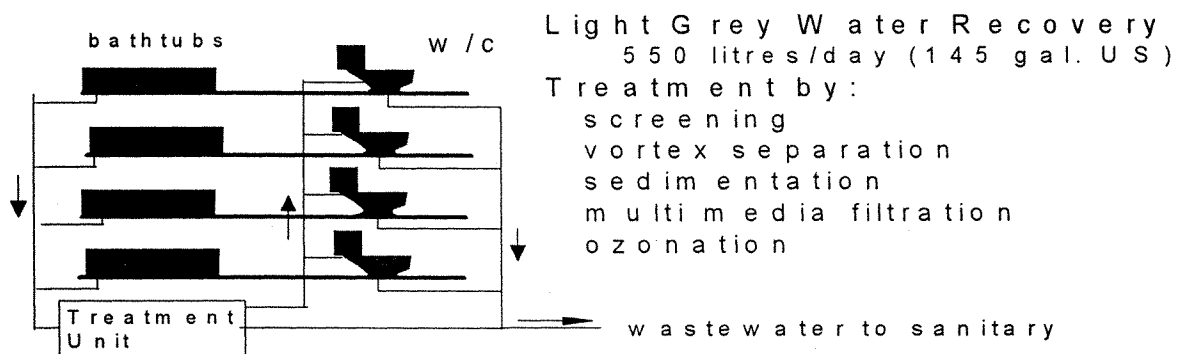
A pilot project grey water reclamation system was designed and installed in the building to evaluate their feasibility within multi-unit residential buildings (Figure 3). The bathtub drains from a vertical stack of 8 apartments (2 per floor) were connected to the grey-water reclamation. The system treats the bathtub water for reuse in the toilets of the 8 apartments. Regular connections to the municipal water and sewer system provide back-up water service as required. A building-wide reclamation system could not be justified due to uncertain costs, benefits and risks.

**Figure 3: Schematic of the Grey Water Reclamation System**

Early system monitoring revealed that the quality of the reclaimed water does not meet drinking water standards but was adequate for toilet use (2). It is estimated that 550 liters/day (145 US gallons/day) could be recovered by the system. While the water cost savings of the pilot system are not substantial (\$331/year), the system demonstrates the possibilities for water savings and reducing sewage flows. If the system capacity was fully utilized, water could be recycled at a rate to 4,000 liters/day saving \$2,400/year in water charges. The capital cost of the system was \$11,300 CDN. Design and installation costs brought the total cost of the pilot project to \$22,800 CDN. The annual cost of electricity to run the plant (pumps, controls) is estimated at \$220 CDN. Since the early trial and monitoring stages, problems have been experienced with the operation and maintenance of the system that have resulted in the system being shut down. An investigation is planned to determine if the problems are inherent in the system itself or are related to operation and maintenance.

**Grey Water Reclamation Project:** The system has experienced problems due to its complexity and the ongoing need for inspection, monitoring and service. It has been found that the superintendent's ability to deal with the system is understandably limited. The operation and maintenance requirements of any unfamiliar or technically complex system must be taken into account when being considered for building projects. This is particularly true for residential projects that do not have onsite building operators.

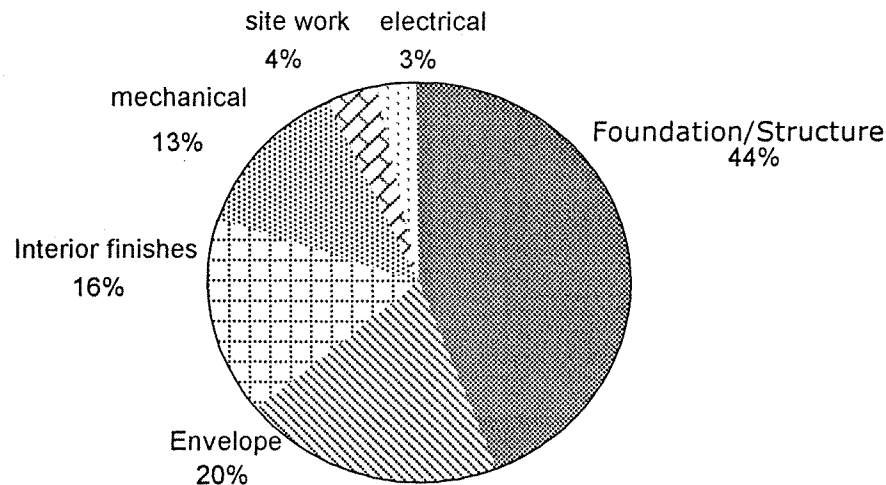
**Embodied Energy:** The initial energy embodied in the building for extracting or recycling raw materials, processing the materials into building products, transportation of the products to the site, and construction was calculated to be 47,800 GJ or 5.25 GJ/m<sup>2</sup> of floor area (3). The relative amounts of energy embodied in the different building materials used in the Co-op building are shown in Figure 4.

**Figure 4: Embodied Energy Proportions by Building System**

The development team had sought to limit embodied energy by selecting building materials having recycled content and by limiting the amount of materials consumed by the project. However, studies of the energy embodied in conventional buildings range from 4.7 GJ/m<sup>2</sup> to 5.6 GJ/m<sup>2</sup> indicating that the efforts to limit the energy embodied in the Conservation Co-op building were not entirely successful. Approximately 64 % of the initial embodied energy consumption is attributable to the building envelope and heavy structure of the building. Almost half (46 %) of the embodied energy of the foundation, structure and envelope can be attributed to structural steel (mainly rebar).

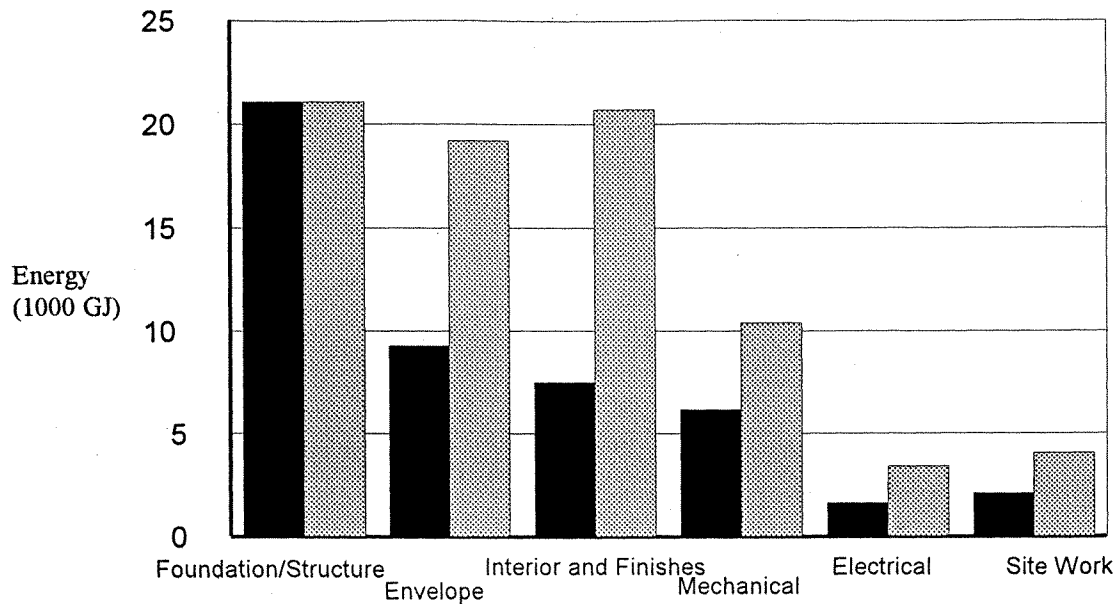
**Life-Cycle Embodied Energy Consumption:** Life-cycle embodied energy accounts for the initial energy embodied in the construction of the building and the energy embodied in the materials and activities required for the repair, maintenance and the eventual demolition and disposal of the building. An analysis of the lifecycle energy requirements estimated the 40 year lifecycle embodied energy of the building to be 79,000 GJ (3). Figure 5 shows a comparison of the initial embodied energy to the lifecycle embodied energy for the main building assemblies.

**Figure 5: Initial Embodied Energy(■) and Lifecycle Embodied Energy(▨)**

Concrete work remains the largest component of the life-cycle embodied energy. The results also show that the interior finishes (carpeting, paint, flooring, etc.) are a significant component of the life cycle embodied energy of the building.

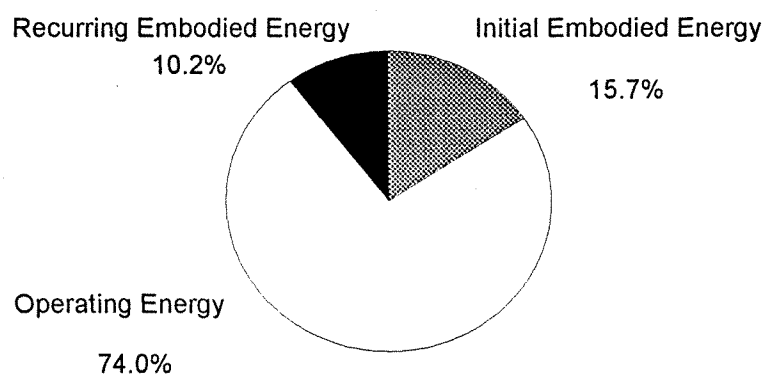
**Life Cycle Energy:** Life cycle energy is the sum of life cycle embodied energy and ongoing operating energy of the building. Based on the preceding analysis, the resultant life-cycle energy consumption total is 0.877 GJ/m<sup>2</sup>/yr (3). Figure 6 shows the distribution of the energy components that make up the life-cycle energy consumption.

**Figure 6: Distribution of Life-cycle Energy Consumption**

The operating energy consumption represents almost  $\frac{3}{4}$  of the total life cycle energy consumption of the building. This indicates that although the initial level of embodied energy of the Conservation Co-op is comparable to conventional buildings, the efforts to reduce operating energy were well placed given the significance of operating energy over the life of the building.
