Where Should We Focus Efforts to Improve Building Energy Code Enforcement Rates? Results From A Research Study in Florida

Charles Withers, Jr. and Robin Vieira, Florida Solar Energy Center

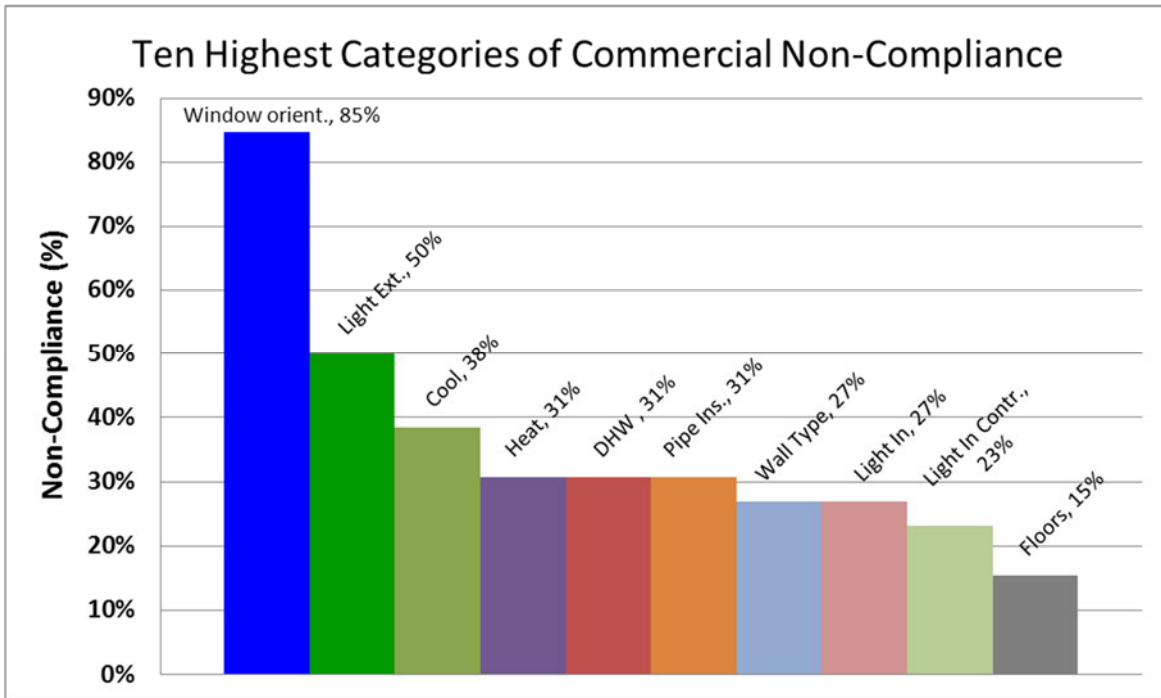
Figure 1 below shows the rates of non-compliance for the ten highest categories. The five highest categories are: window orientation, exterior lighting, cooling efficiency, heating efficiency and domestic hot water efficiency. The annual energy impact of window orientation also largely depends upon total glass area, presence of shading, and window performance characteristics.

Figure 1. Top ten highest non-compliance categories.

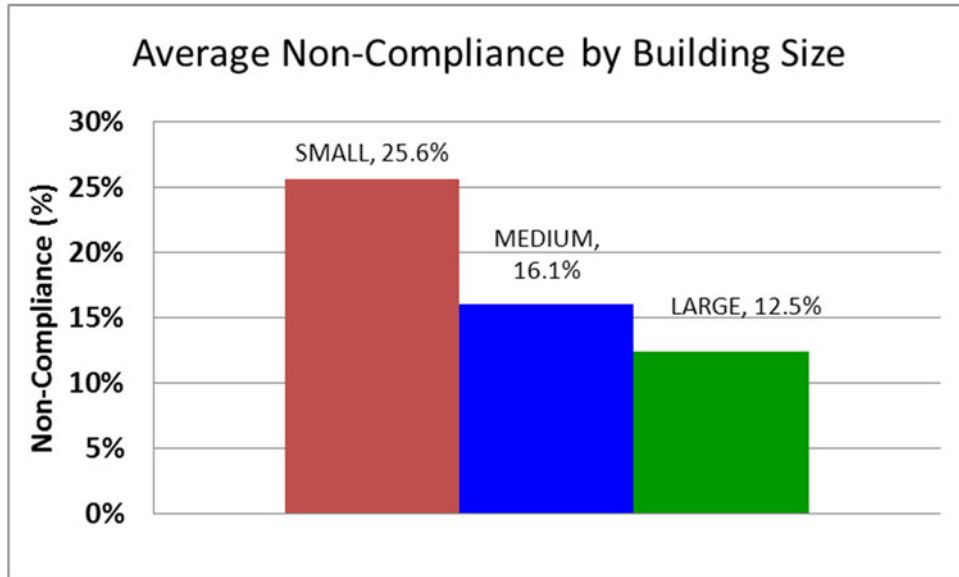
A trend is indicated when the average non-compliance is sorted by the building size category as illustrated in Figure 2. The average non-compliance by building size is about 26% for small, 16% for medium and 13% for large buildings showing a trend for better compliance enforcement as buildings become larger.

Figure 2. Average non-compliance sorted by building size classification.

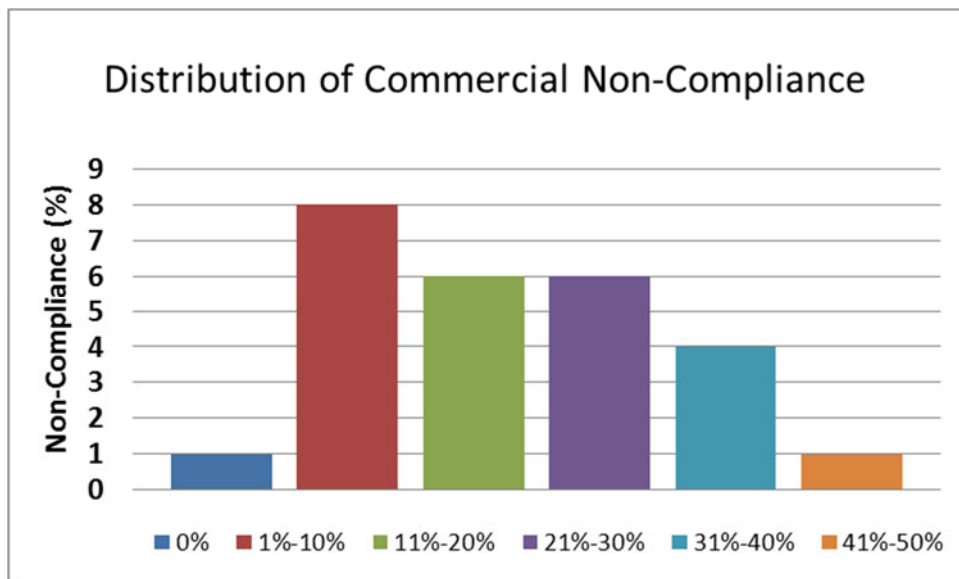
Figure 3 illustrates the number of audited buildings that fell into bins of percentage of problems. Just one of the inspected buildings had no compliance issues. Nine of the 26 buildings had 10% or fewer issues; however 16 buildings had over 10% non-compliance issues. When you consider that 24 buildings had some non-compliance issues at permit time, there are significant enforcement issues both during permitting and inspection.

Figure 3. Frequency distribution plot for commercial energy code compliance. The height of each bar represents the number of inspected buildings that had the binned value of non-compliance issues.

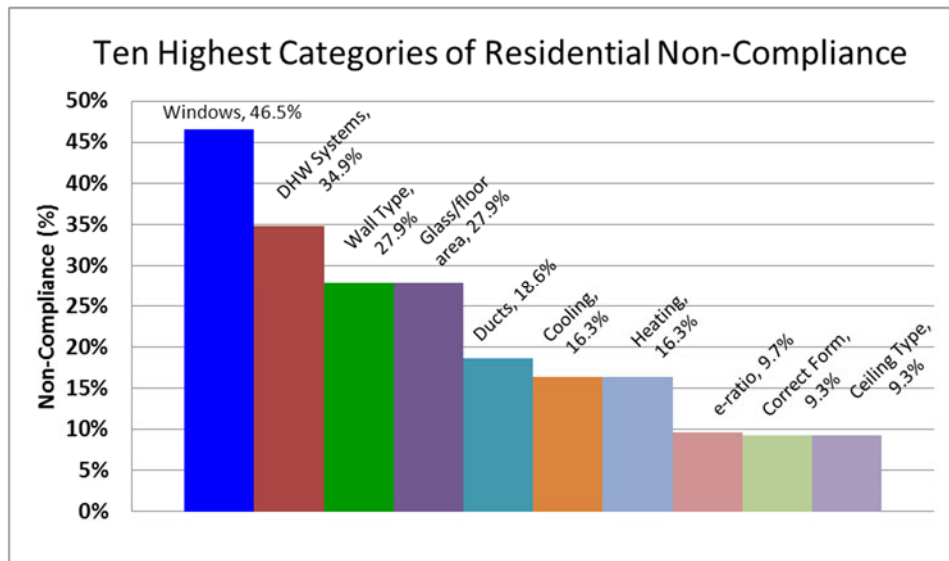
Figure 4 below shows the rates of non-compliance for the ten highest categories. The most common non-compliance was in the Windows category at a rate of 47%. Window non-compliance was related to window area, orientation or shading related errors. Window U value and SHGC labels are removed when the home is completed; however window performance data was available in about 3 houses. In those cases we confirmed that the installed performance data met or exceeded the claimed efficiency. Non-compliance could be counted based on performance rating if the claimed window performance was not plausible.

Figure 4. Top ten highest residential non-compliance categories.

After windows, the next five highest rates of non-compliance occurred in domestic hot water heating (35%) where the claimed EF was higher than installed, glass/floor ratio (28%) where the ratio claimed was lower than installed, Walls (28%), Ducts (19%) and Cooling and Heating each having 19% non-compliance. The reason for wall non-compliance was usually related to over-stated R-value on code forms or significant wall area errors. Duct issues were typically related to wrong claimed location (indoor versus attic) or claiming much smaller duct surface area than installed. Non-compliance in cooling and heating was due to installation of lower efficiency equipment in half of the cases. Most of the time the SEER difference was about 1 SEER lower and HSPF about 0.3 lower. The other half of non-compliance in heating and cooling was noted for installation of significantly oversized equipment. Figure 5 illustrates the audited buildings that fell into bins of non-compliance.
