Case Study in Building Commissioning and Savings Verification Applied to a 311,000 ft²Office Tower Retrofit

Howard S. Reichmuth, Lambert Engineering Kevin C. Fish, Microgrid, Inc.

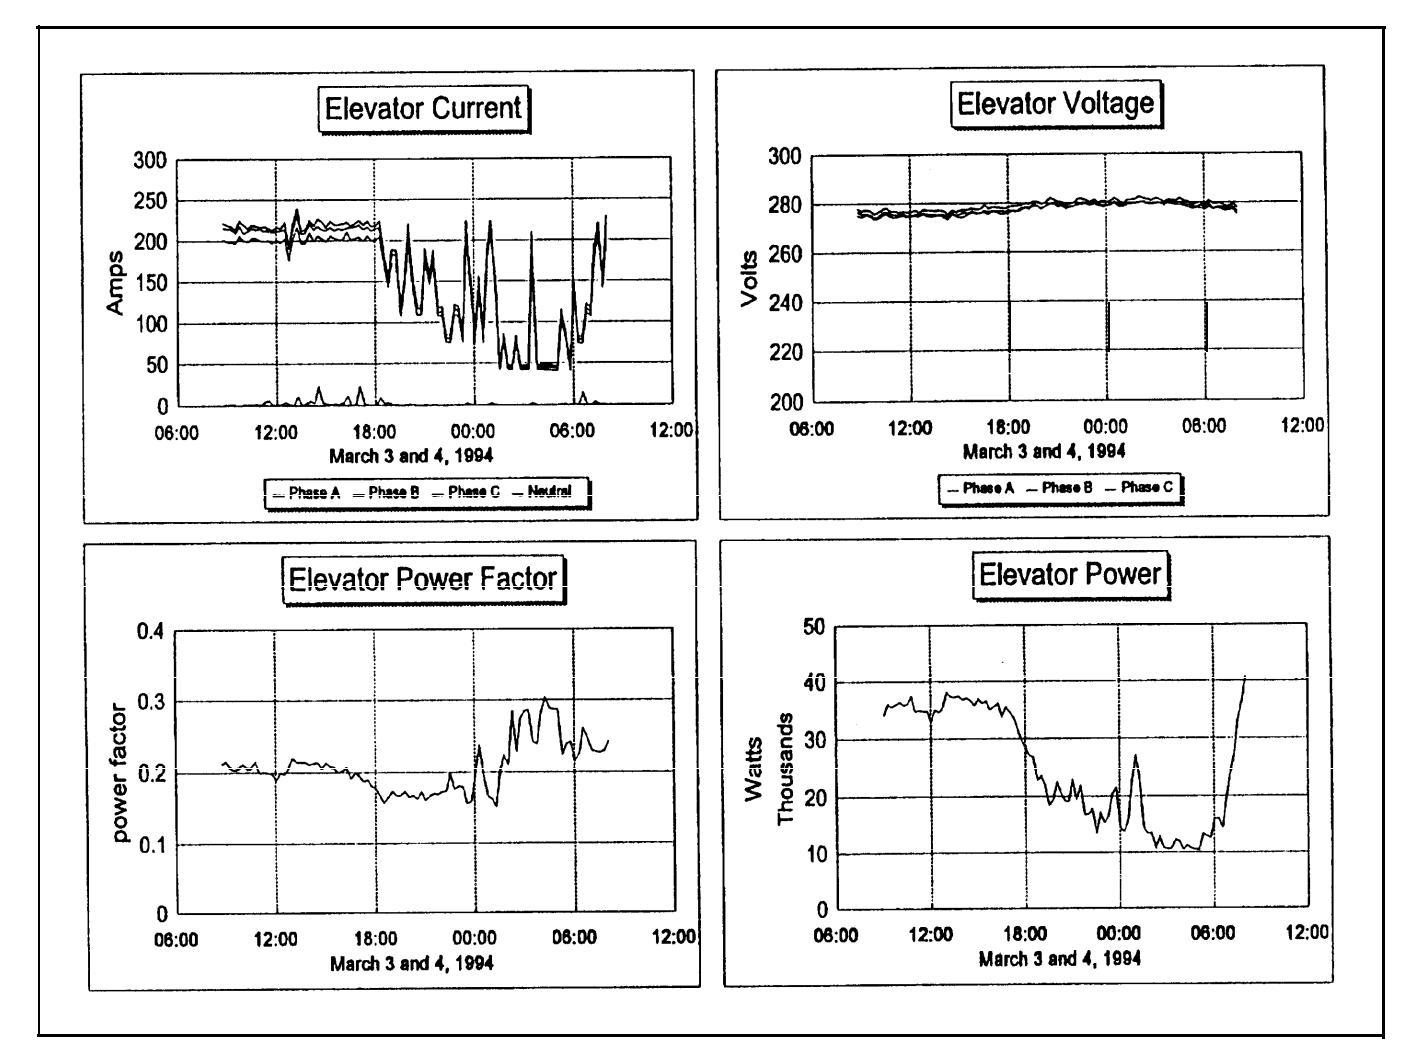
Figure 2. Elevator Load Measurements

A recording power meter monitored the load a second time. A sample of these measurements shown in Figure 2 shows how the elevator power and power factor varies with time of day. Figure 3 shows the measured elevator power superimposed on the assumed elevator power used in DOE2. Overall, DOE2 assumed slightly more elevator power than we measured, or about 300 kWH/day.

Elevator Loads. Current loggers originally monitored the total power of the vertical transport. The use of current loggers on this type of load is inappropriate because the load has a low and varying load factor.

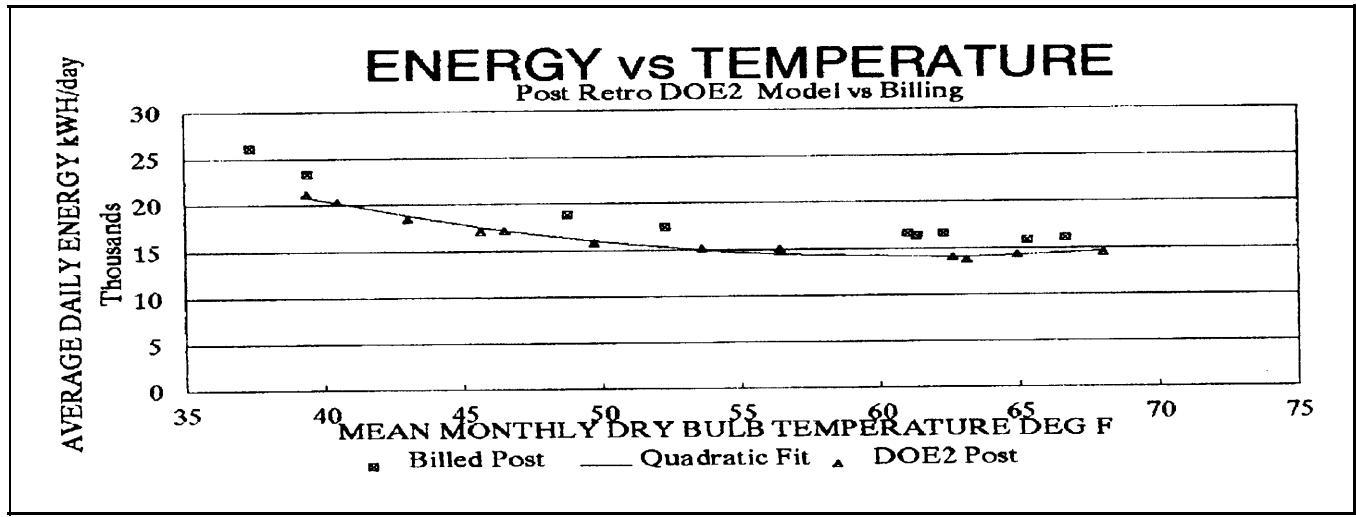
Figure 4. Post Retrofit DOE Prediction vs Billing Data

We reduced the billing data to kWH/day to normalize for billing interval and plotted versus the average monthly temperature as shown in Figure 4 below. Figure 4 is also a convenient format for presenting DOE2 estimated monthly performance. In general, this method of presentation shows the energy use as predicted by DOE2 and the billed energy use both varying in a coherent manner with temperature. An imaginary line connecting the DOE2 predictions becomes a performance threshold;

- Billing points above the line show performance worse than predicted, and
- Points below the line show performance exceeding predictions.

In this case, the post-retrofit billing data is close to the DOE2 predictions.

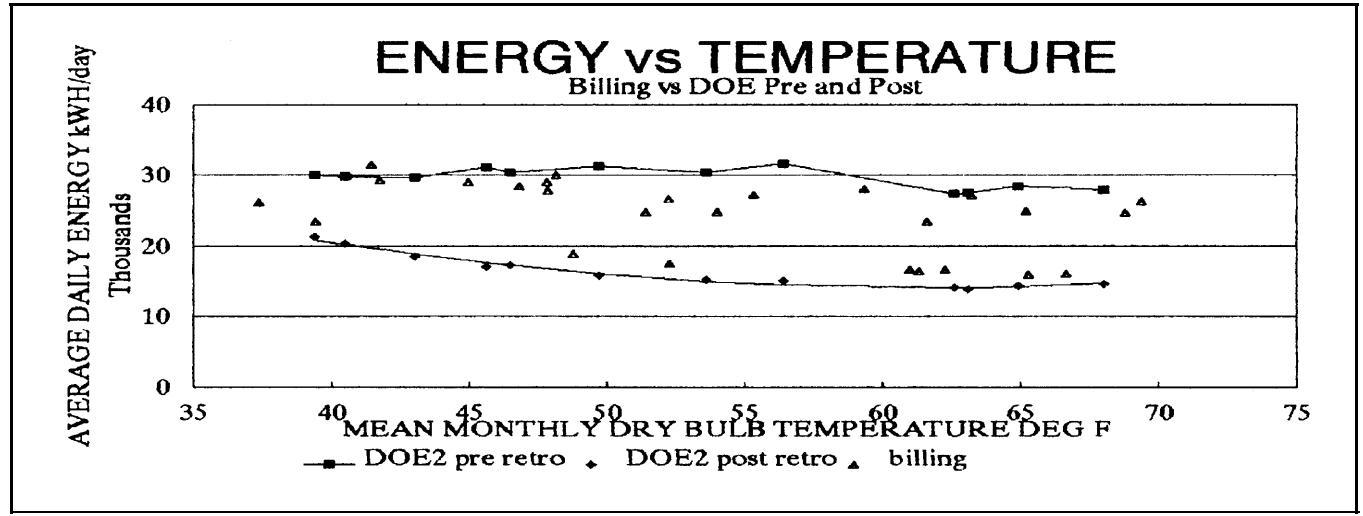
Figure 5. Billing Data vs DOE Pre- and Post-Retrofit

The initial estimates of savings for this building were based on the difference between the DOE2 modeled preand post-retrofit performance. Savings estimated in this manner were 45%. However, the pre-retrofit model does not fit the pre-retrofit billing data very well, as is clear from Figure 5 below.

Because the pre-retrofit model fits the pre-retrofit billing data so poorly, it could not be used confidently as a preretrofit baseline. Therefore, we developed an alternate method of estimating the savings.

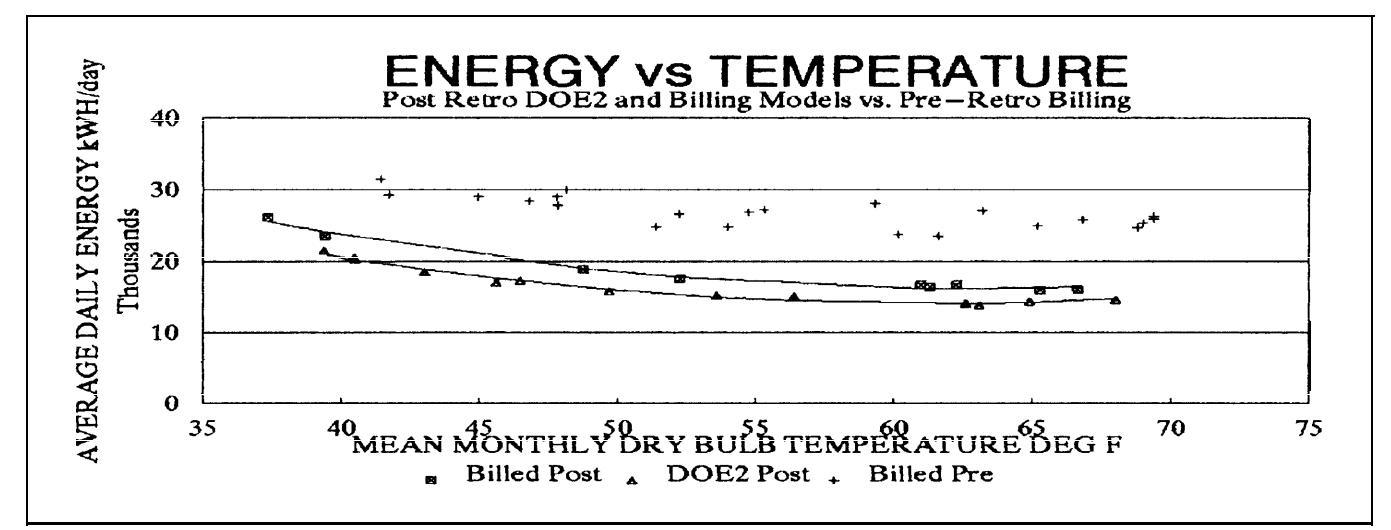
Figure 6. Backcast of Post-Retrofit Models on Pre-Retrofit Data

Since these savings will represent the average savings for only two specific pre-retrofit weather years, they may differ from the true long term average savings. However in this case, these specific savings are preferable to using an inaccurate pre-retrofit baseline. This comparison is done by fitting a quadratic equation to the DOE2 post-retrofit and to the billed post-retrofit data. The quadratic fits quite well in both cases, as illustrated in Figure 6.

The use of a quadratic fit in this case is purely empirical. The purpose of this fit is to "interpolate" kWH/day to preretrofit average monthly temperatures. These temperatures may vary by a few degrees from either the TMY monthly average temperatures used in DOE2 or from the temperatures corresponding to the billing data.

Using this method of comparing the monthly pre-retrofit kWH/day figures to the DOE2 and post-retrofit figures at the pre-retrofit average monthly temperatures yields a DOE2 predicted savings of 41% of the pre-retrofit energy use, and an observed savings of 33%.
